LANDSLIDES: AN ENVIRONMENTAL HAZARD IN THE PIR-PANJAL HIMALAYAN RANGE IN POONCH DISTRICT OF J&K STATE, INDIA

ABSTRACT

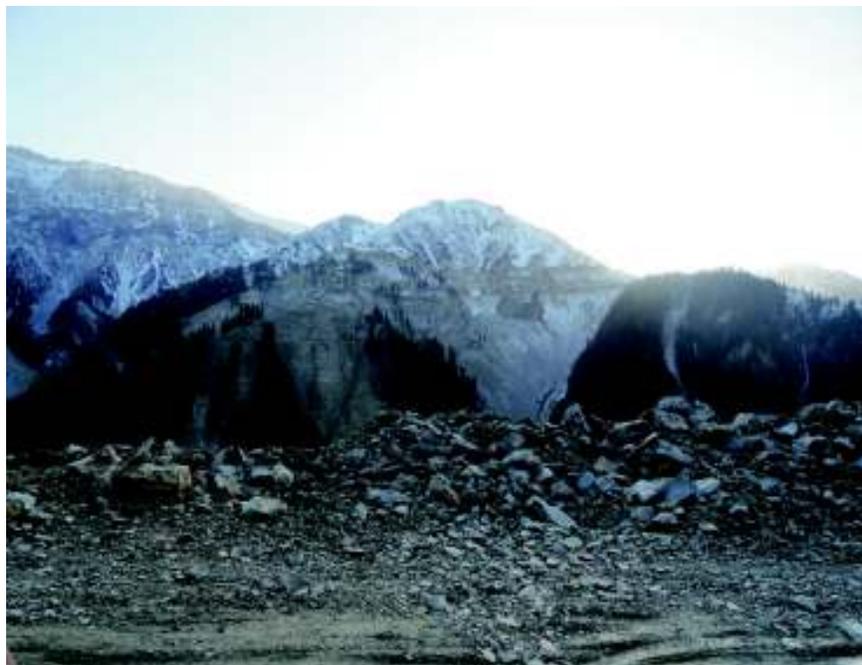
Figure 1: A segment of Historical Mughal Road In Pir-Ki-Gali Sector of Poonch

from Kashmir valley by the gigantic Pir-Panjal range of the Himalayas whose highest peak Tatakuti standing at 15560 ft above sea level falls in Poonch. The historical Mughal road links up Poonch region of Jammu and the Kashmir valley (Figure, 1).

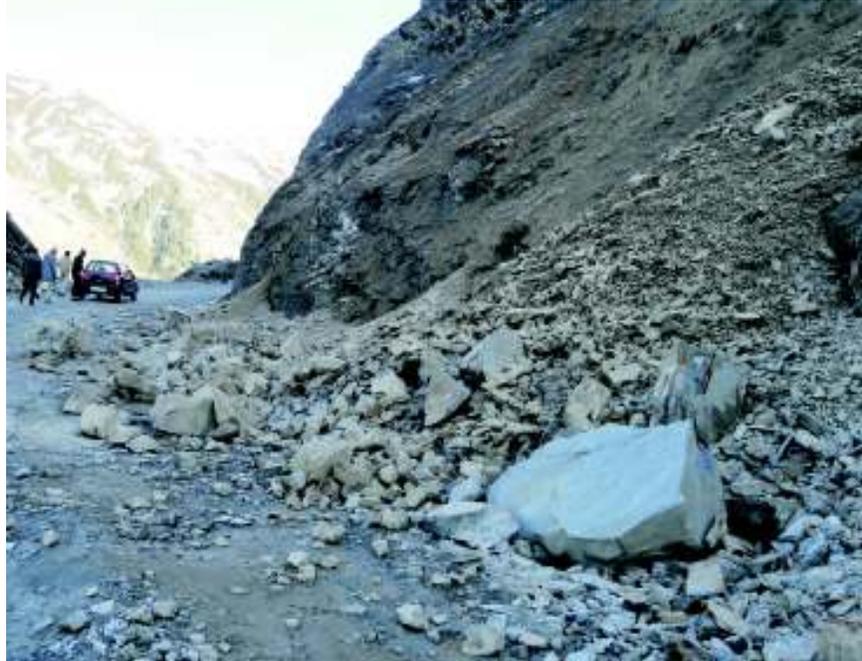
Figure 2: A Landslide Prone Area Along The Mughal Road Which Occurred Instantly As The Authors' Vehicle Crossed The Site

The study area is characterized by monsoonal climate where the rainfall starts from the month of July and continues till September. The average annual rainfall recorded was approx. 1500-2000mm. This study area also experienced precipitation in the form of heavy snowfall from October to March every year as is evident from shots which were clicked during October 2011 overland flow is a common phenomenon during rainstorms. This may have been due to precipitation intensities exceeding soil infiltration with consequently greater surface run off over the soils which has only reduced the slope stability but also caused slumping down of the debris and loose soil leading to landslides as witnessed at Maansar (Figure, 2).

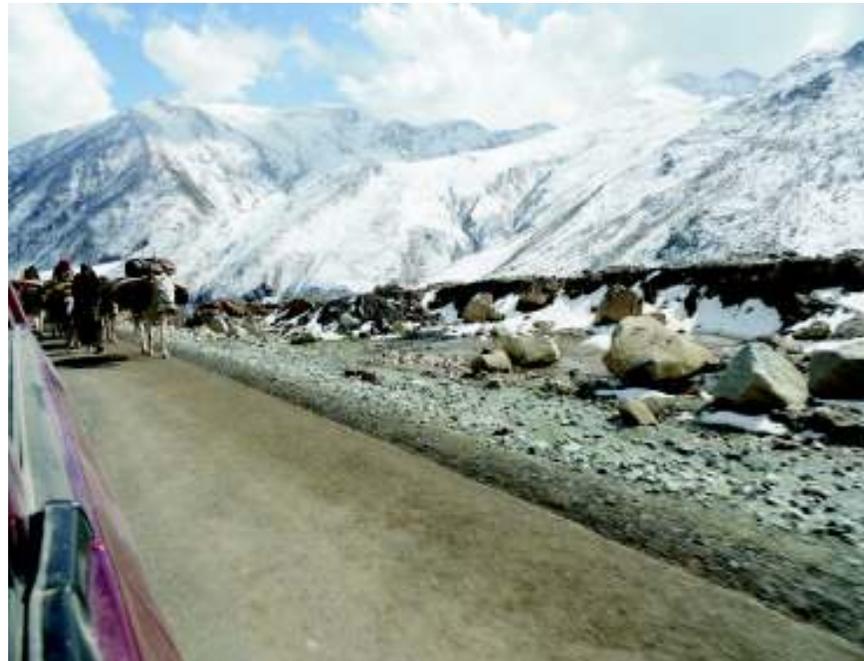
Figure 3 : A Nomad Along With A Flock/herd Of His Livestock Another Anthropogenic Pressure On The Natural Resources Along Mughal Road

them are known as “margs”, the comparatively flat lands devoid of the tree growth and supporting a thick grass cover. Nomad grazers called gujjars and bakerwals own large herds of cattle and sheep (Figure 3), use there margs for grazing of their livestock. The pressure of grazing on the mergs and the forest areas, adjoining these pastures is far above the carrying capacity of these areas which has caused rapid deterioration of the pasture lands, soil erosion and insignificant regeneration of forests on account of heavy trampling and browsing.

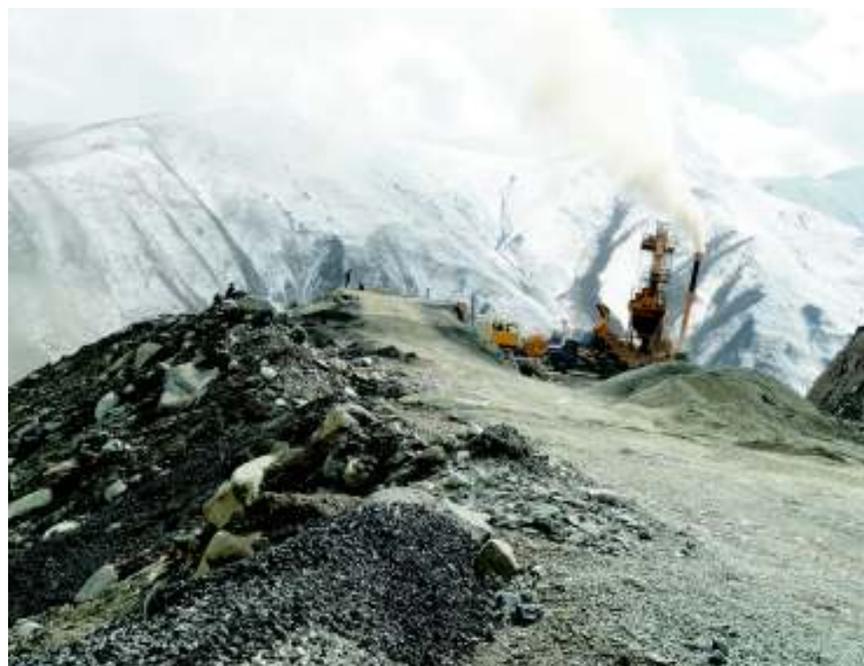
Figure 4 : Infrastructural Development Along The Mughal Road For Recreational Purpose

The infrastructural development in this region has involved the mass consumption of timber from the local forests and also stones being extracted (Figure 4) from surrounding landscape. Soft rocks have been excavated manually while harder portions are blasted which weakens the rocks and debris produced has been dumped on the slope to further aggravate the situation. Construction of the motor able roads far & wide, for instance, along Mughal road has pierced the forest cover by massive felling of trees which has adversely affected the ecosystem.
